Investigating Malaysian Tropical Ground: JKR Experiences

2. Construction of 4-lanes highway for Infrastructure and Public Facilities for Construction of Pengerang Integrated Petroleum Project

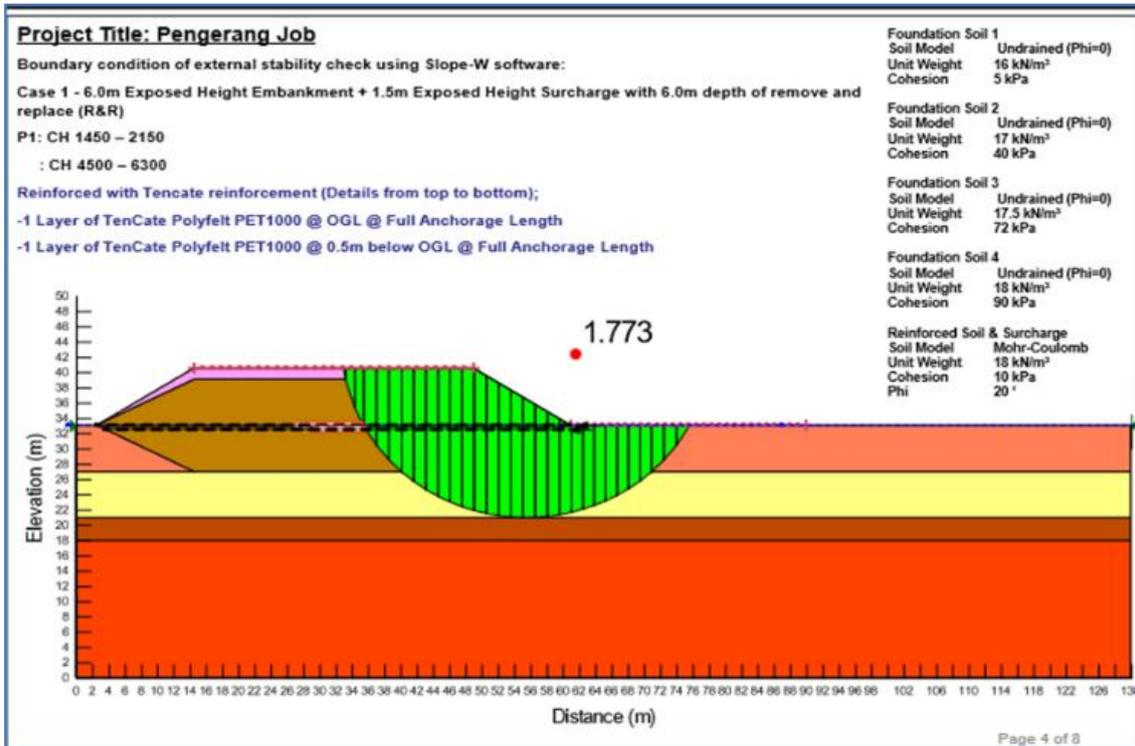
Fig. 3 - Slope stability analysis Case 1

Slope stability analysis was carried out by the consultant in order to check the factor of safety of the embankment for remedial work. Boundary condition of external stability check using Slope-W as shown in Fig. 3, Fig. 4 and Fig. 5. Boundary condition of external stability check using Slope-W software. There are three cases of analysis using different soil parameters at foundation soil 2 whereas the soil parameter for foundation soil 1 is remained constant. It was proposed to be 6.0 m Exposed Height Embankment + 1.5 m Exposed Height Surcharge with 6.0 m depth of remove and replace (R&R) for Phase 1 of CH 1450 – 2150; CH 4500 – 6300.

The stability check is based on back analysis and the C_u for foundation soil 1 (very soft soil) is 6 kPa but in the analysis 5 kPa is adopted on a conservative basis. The C_u for foundation soil 2 (soft soil) is 40 kPa. Sensitivity analysis is done for foundation soil 2 (soft soil) in which the C_u will be as low as 20 kPa and 15 kPa. With the stability analyses check, it is still recommended that further soil investigation need to be done including CPT/vane shear to further confirm the soil parameters used. The results of the analysis for remedial work are summarized in Table 3 as below.

Case	Foundation Soil 1	Foundation Soil 2	No. of Reinforcement	Factor of safety
1		$C_u = 40$ kPa	2 layers of Mirafi PET1000	1.773
2	$C_u = 5$ kPa	$C_u = 20$ kPa	2 layers of Mirafi PET1000	1.276
3		$C_u = 15$ kPa	2 layers of Mirafi PET1000	1.145

It can be concluded that the tension cracks embankment need to be excavated at certain level (the remove and replace level) and further soil investigation need to be carried out.
